Revisiting the Mosaic of the Masks on Delos: a Comprehensive Condition Survey

Revisiting the Mosaic of the Masks on Delos: A Comprehensive Condition Survey

A condition survey was conducted on the 'Mosaic of the Masks' located in the homonymous Hellenistic house on Delos to reassess its condition twenty years after conservation efforts. This mosaic adorns the central symposium room and comprises a central geometric carpet with a 3D cube pattern, along with figurative bands featuring theatrical masks and floral motifs. Extensive and drastic conservation treatment was applied to the central carpet, involving its detachment in sections and reinstallation on a new, purpose-built setting bed, while the peripheral sections were preserved in situ. The particularly poor state of preservation necessitated thorough research into the weathering processes and the factors affecting its condition. Investigation into the archival records, the original constituents, conservation materials and past conservation interventions were conducted to better understand the deterioration processes. Photogrammetric methods were employed in the study and documentation of surface geometry, while the cohesion o

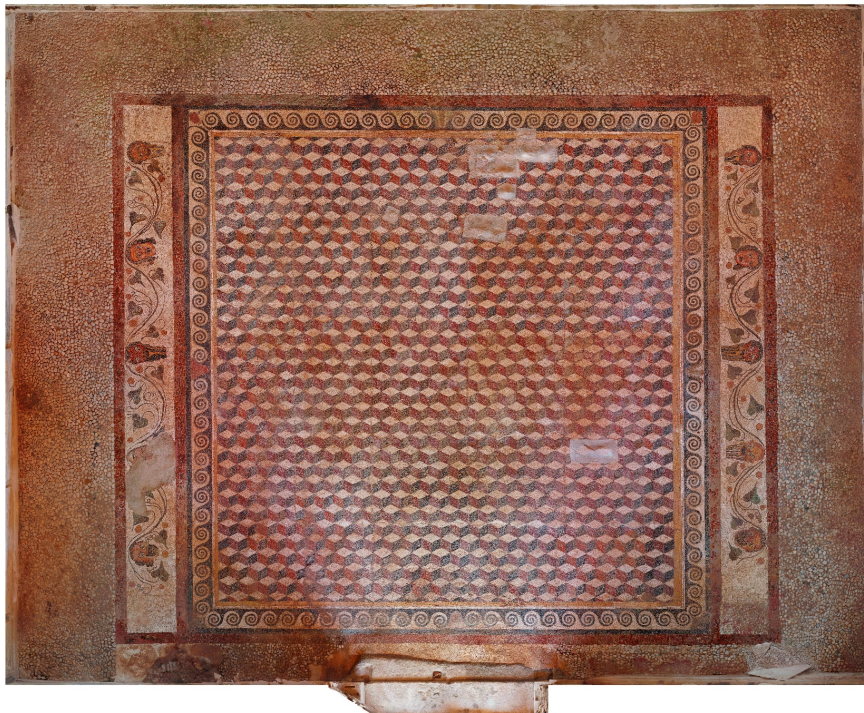
The mosaic under study, measures 9.12 x 7.09 meters and features a central geometric pattern consisting of '3D cubes', a recurring geometric pattern in Hellenistic mosaics, characterized by the depiction of cubes arranged in a three-dimensional manner. The central pattern is bordered by a decorative band of waves, with two lateral bands on the east and west, each showcasing five theatrical masks, interwind with floral motifs. The outer band is plain giving the illusion of a big carpet placed on the floor (Fig.1).

Fig. 1. Orthophoto of the mosaic of the Masks, 9.12 x 7.09 meters (by C. Maris)

Both handheld digital cameras and drones were utilized to capture images. A first set of 974 images were acquired before cleaning, followed by a set of 857 images after dry cleaning. The first two sets of images were shot from a height of approx. 0,5 m, with a 70% overlap, a rather a time-consuming and labor-intensive process. Image processing was similarly challenging due to the large number of images. A third set of 187 images were acquired with a drone from a steady distance of 3 m. The 3D-model, the orthophotos and the digital elevation model (DEM) provided metric information and enabled the study and documentation of surface geometry alterations related to natural deterioration and to previous conservation treatments. The orthophotos served as a base for accurately mapping surface and structural conditions, while the point cloud and the DEM provided the basis for monitoring subsequent changes in the geometry of the mosaic, allowing for the assessment of the evolution of decay (**Fig 1-2**).

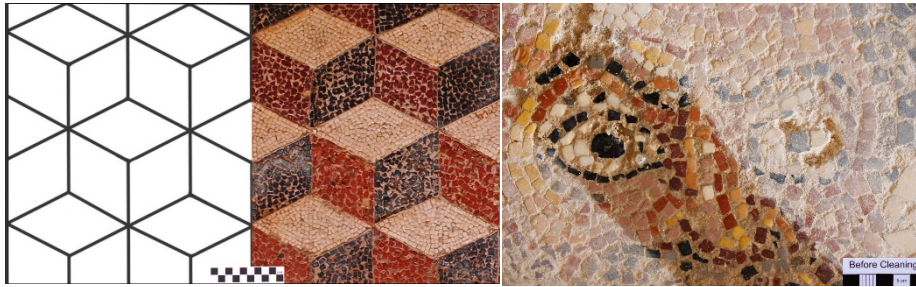
A variety of materials and fabrication techniques are employed. The sides of the cubes are set in *opus segmentatum*, characterized by the random setting of irregular red and

black tesserae with wide and irregular interstices (Fig. 2). In contrast, the top of the cubes is set in *opus tessellatum* characterized by a well-organized *andamento*, using white tesserae of approx. 1 cm side arranged in concentric lozenges [3]. Additionally, lead strips [4,5] are used to define the sides of the rhombuses that form the three-dimensional cubes and the outlines of the waves. *Opus vermiculatum* is used in the masks and *opus tessellatum* in their background, the floral motifs and the rest of the decorative bands. Glass tesserae are used in a few details of the masks while the rest of the mosaic is made of stone tesserae.

Fig. 2. Detail of the 3D cube pattern of the central mosaic carpet (photo and drawing by S. Minetou).

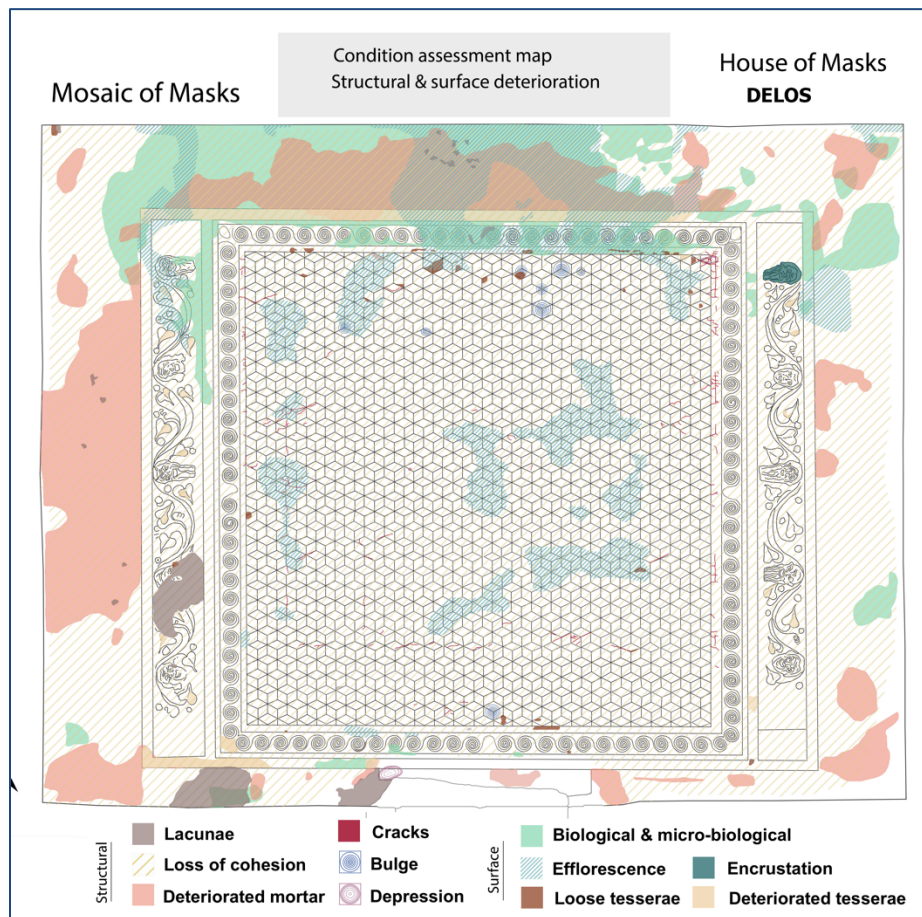
The entire mosaic was covered by loose deposits originating from the disintegration of the wall plasters and the masonry, concrete and iron fragments collapsed from the roof, as well as biological depositions. Acoustic tapping indicated the loss of cohesion between the mosaic surface and the substrate across the entire floor, in particular on the previously detached area. Extensive disintegration of the interstitial mortar was observed at the *opus segmentatum* of the outer band, especially in the northern and western part of the floor, leading to loss of adhesion and often to detachment of tesserae. Cracks, bulges and rises were concentrated in re-laid areas. Salt efflorescence covered the northern side, which kept reoccurring shortly after their removal. The green tesserae are extensively eroded, often partially or completely pulverized. The ceramic tesserae on the north and west sides show cracking, exfoliation, erosion as well as biological and microbiological colonization (**Fig. 3**).

Rainwater seepage from the north side of the roof and walls favors salt migration and biological colonization on both the masonry and the mosaic floor. Soluble salts and iron corrosion products originating from the restoration materials are leaching and transported to the mosaic floor. Severe corrosion of the metal bars is observed at the northern part of roof causing the detachment of small fragments of the concrete slab and rendering the mosaic inaccessible to visitors. The incorporation of incompatible intervention materials into the new substrate further contributes to the continuous degradation of the mosaic. In addition, Besides the action of insect swarms which create colonies inside the masonry, intensify the degradation of the wall plasters resulting in their gradual collapse on the mosaic surface. It is evident that the severe condition of the mosaics is largely owing to the detrimental effects of the past restoration practices. When comparing the detached portion of the mosaic with the part that remained in situ, it becomes evident that the detachment has led to enhanced deterioration. In addition to the severe

deterioration of the mosaic substrate and surface, the misalignment of the re-laid sections compromises the aesthetic values of the mosaic floor, also affecting the broader architectural context.

Fig. 3. Condition map, showing the prevailing surface and structural conditions (by S. Minetou).

Moving forward, it is imperative to implement targeted mitigation strategies to safeguard the '*Mosaic of the Masks*' against further deterioration. This may include new conservation treatments targeted to the detached area after further research and pilot on-site applications.

It's evident that immediate action is necessary to address these issues. Proper maintenance is essential to prevent further damage and ensure the safety of both workers and visitors. This may involve repairing the roof, improving drainage systems to prevent water seepage, and implementing measures to control moisture and biological growth. Additionally, steps should be taken to make the mosaic accessible to visitors once again, as it's an important part of the building's heritage.
